*Experimental Construction Project ME 00-20
Third Year Interim Report on Experimental
Utilization of Tire Shreds to Enhance Highway
Drainage
April 2003*

Third Year Interim Report on Experimental Utilization of Tire Shreds to Enhance Highway Drainage

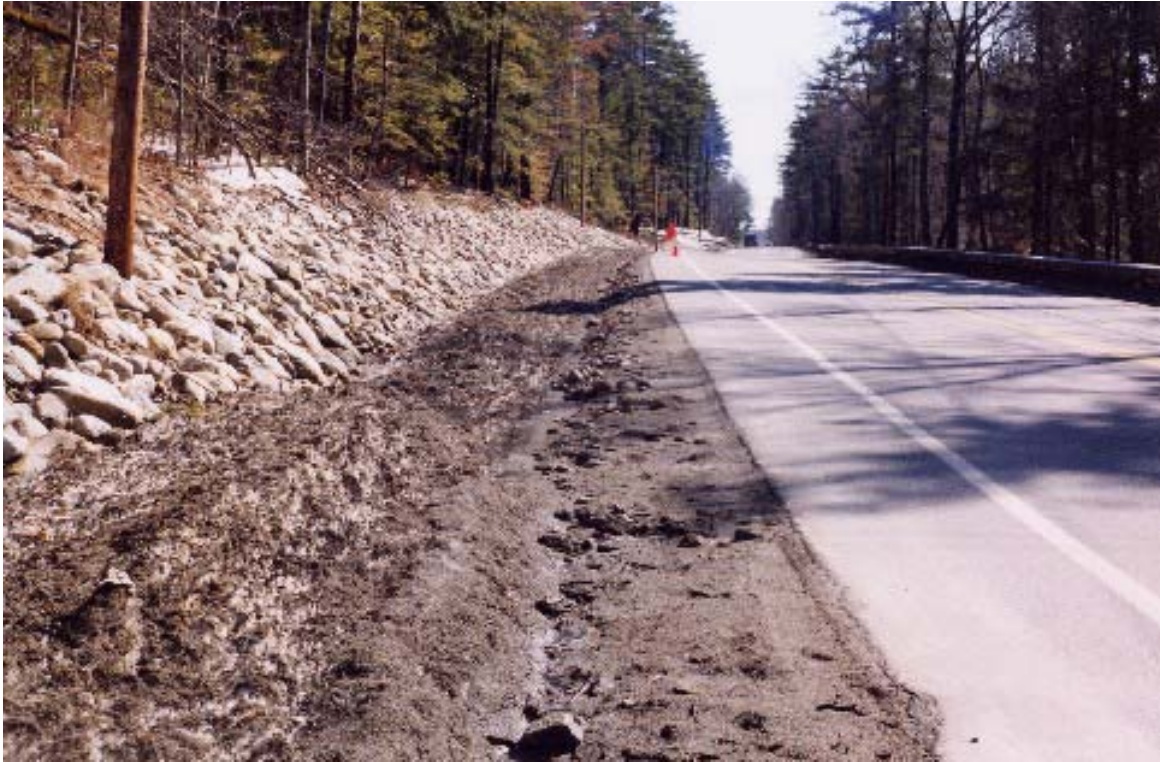
Figure 2. Ice & Snow Remain in the Ditch Long After Other Areas Have Melted

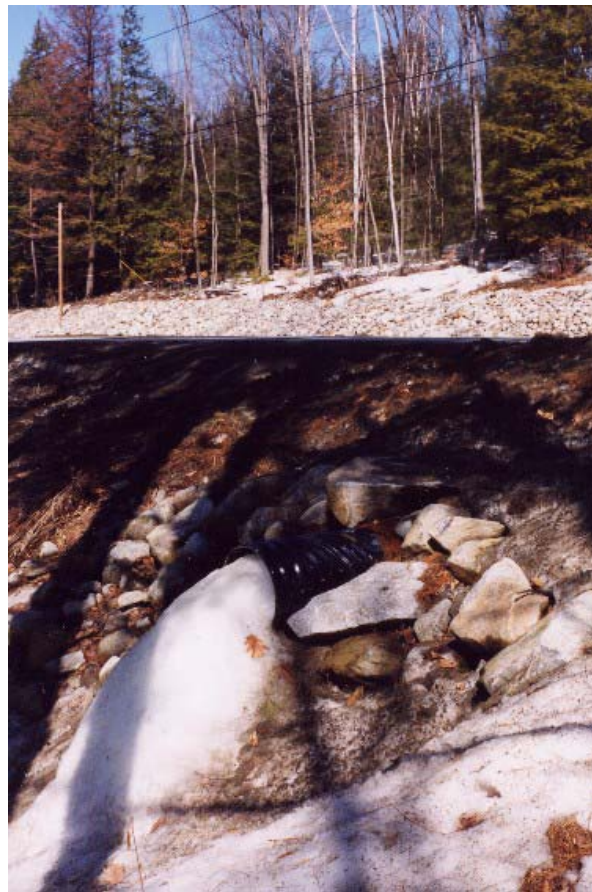
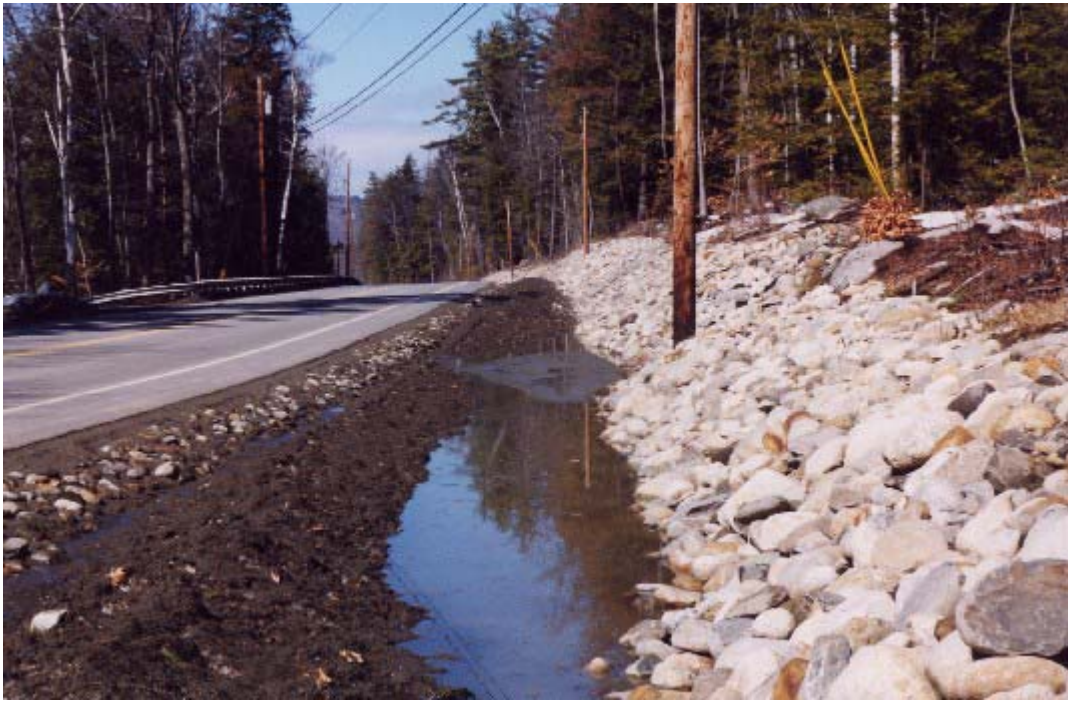
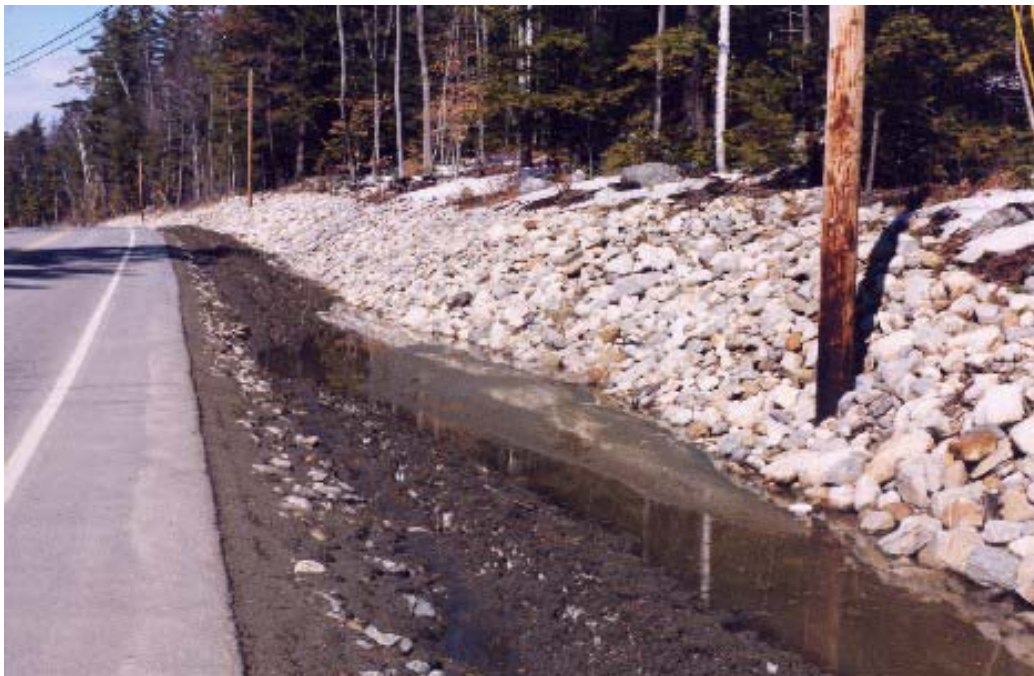
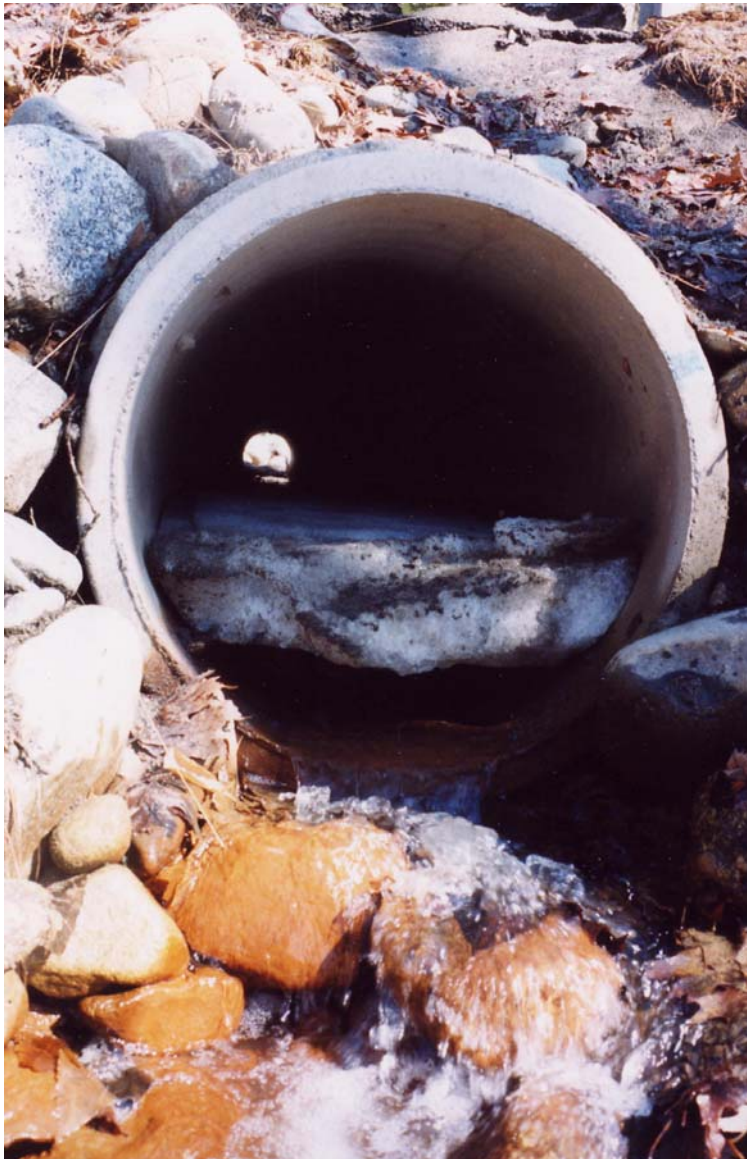
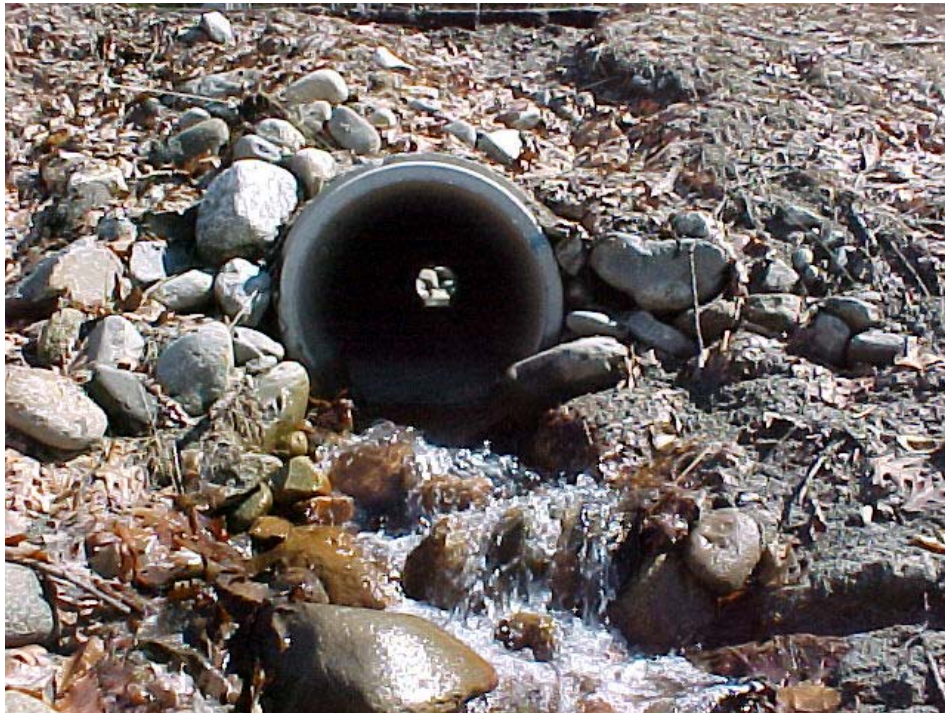
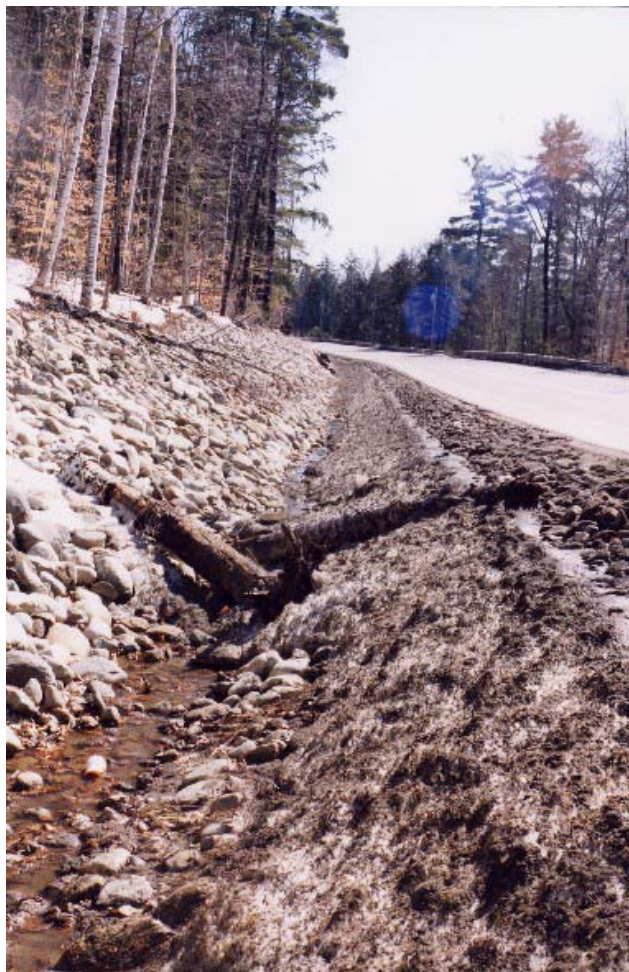
One notable problem occurred at station 14 +330 where some ponding occurred in the ditch. A culvert plugged with ice prevented cross drainage. This problem does not appear to be related to the subsurface drain or the tire shreds, since all other adjacent drainage structures were functioning properly.

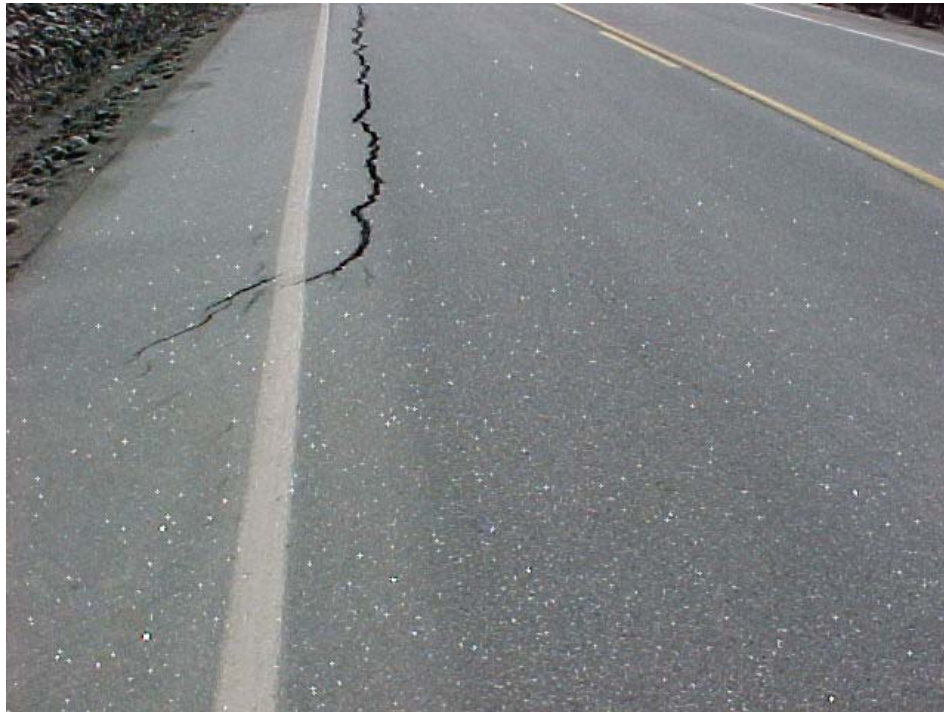
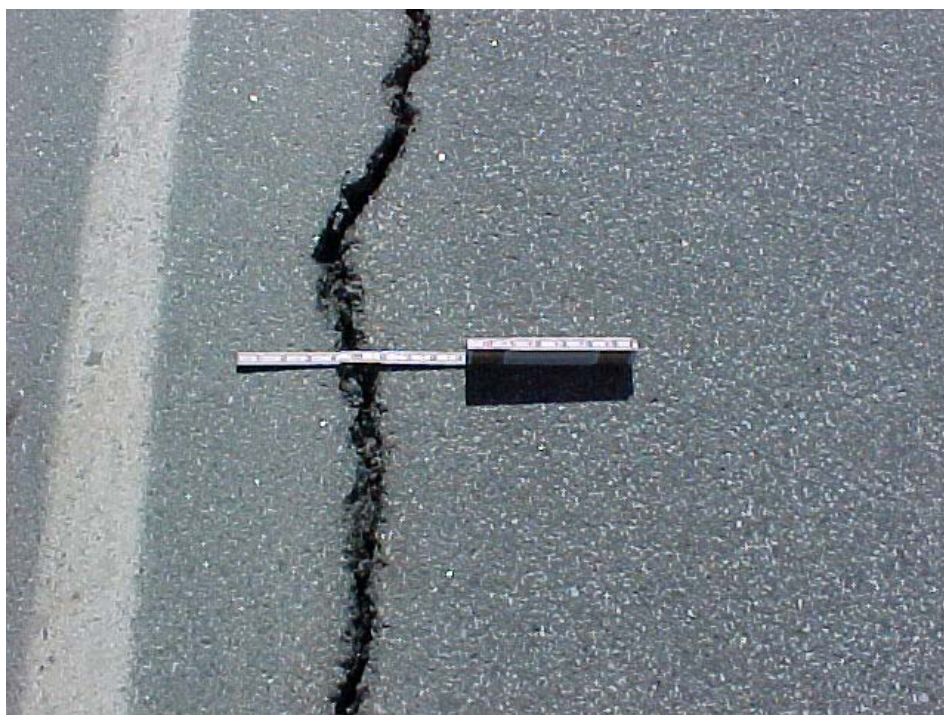
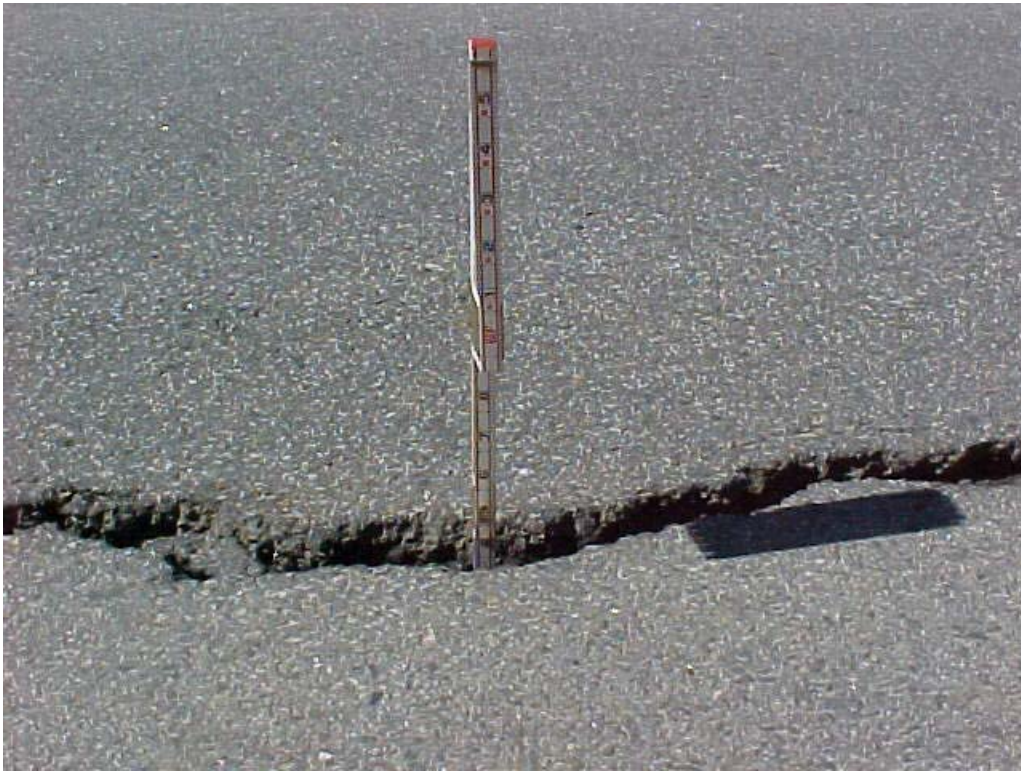
A severe crack has developed in one lane adjacent to the experimental area. It is not known if this crack is directly related to the subsurface drain, since the drain was not underneath the travel way. It may be that it is related to post construction settling adjacent to the drain.

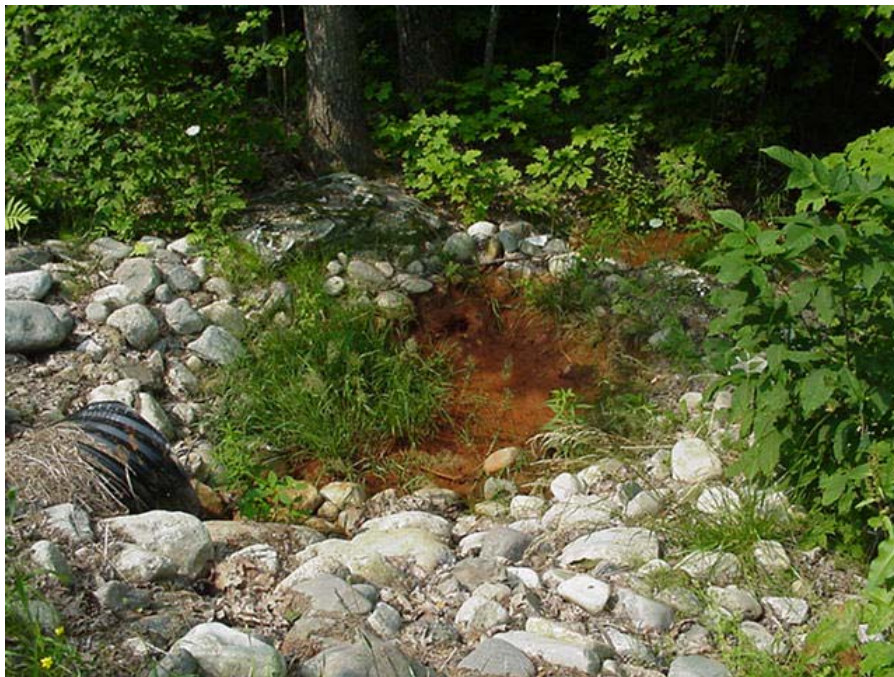
Another problem that is of concern is the discoloration in the culvert discharge areas. The photos below show this phenomena. It is believed that it is due to iron bacteria or rust from the steel belts in the shredded tires. While this is not a water quality issue, it is an esthetic consideration. Although the discoloration does not appear to pose any hazard, MDOT staff feel this will limit the locations where tire shreds can be utilized in the future.

Figure 20. Rust Discoloration Visible on Soil & Rocks

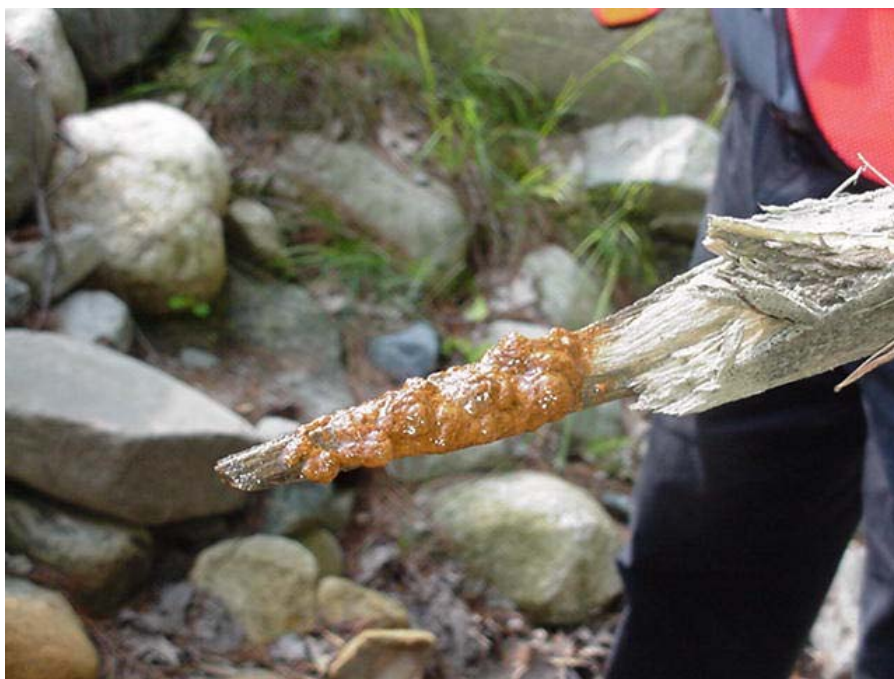
Figure 21. Surface Deposits Caused by Iron Bacteria
